CAFO FACILITY INSPECTION REPORT

<u>8335286001A</u> WDID NUMBER	<u>Pete Vanderham</u> OWNER NAME	<u>Pete Vanderham Dairy</u> FACILITY NAME
<u>CAG018001</u> NPDES NUMBER	<u>Ex. 6 Personal Privacy (PP)</u> OWNER ADDRESS FACILITY ADDRESS	
<u>R8-2007-0001</u> RWQCB ORDER NO.	<u>Mira Loma, CA 91752</u> OWNER CITY AND STATE	<u>Mira Loma, CA 91752</u> FACILITY CITY AND STATE
<u>03/07/2013</u> SCHEDULED INSPECTION DATE	<u>Pete Vanderham</u> OWNER CONTACT	<u>Pete Vanderham</u> FACILITY CONTACT
<u>03/07/2013</u> ACTUAL INSPECTION DATE	<u>Ex. 6 Personal Privacy (PP)</u> OWNER PHONE NO. FACILITY PHONE NO.	
<u>Unknown</u> RECEIVING WATER	<u>Ex. 6 Personal Privacy (PP)</u> FACILITY LATITUDE	<u>Ex. 6 Personal Privacy (PP)</u> FACILITY LONGITUDE

REPORT PREPARED BY: Jared Richardson (PG Environmental, LLC) ON 03/29/2013

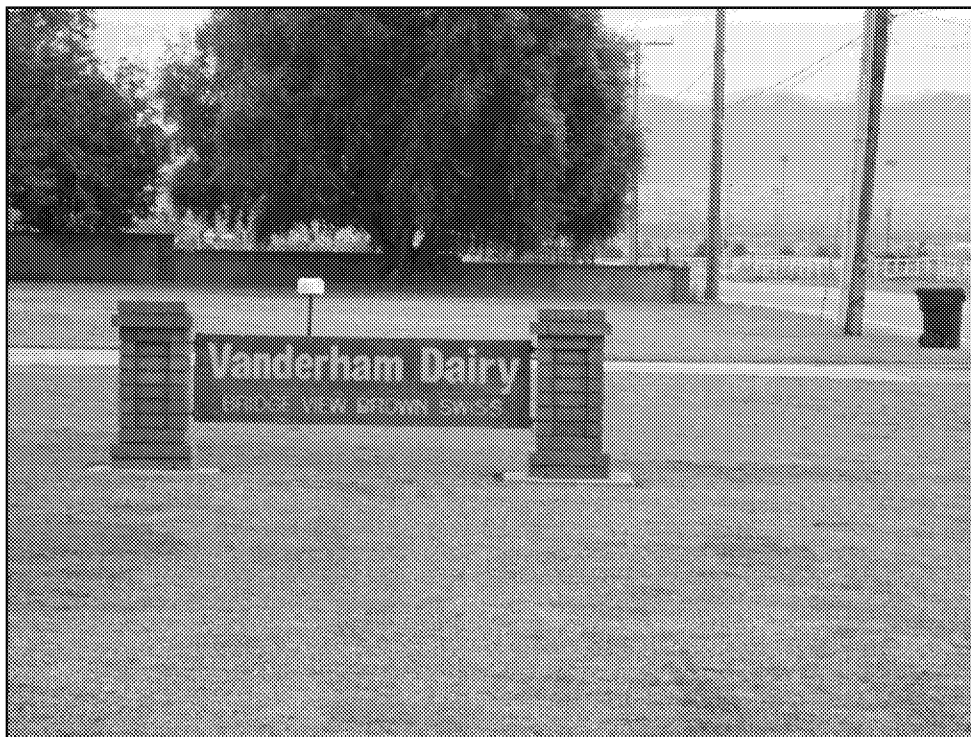
Photograph 1. Pete Vanderham Dairy Facility sign.

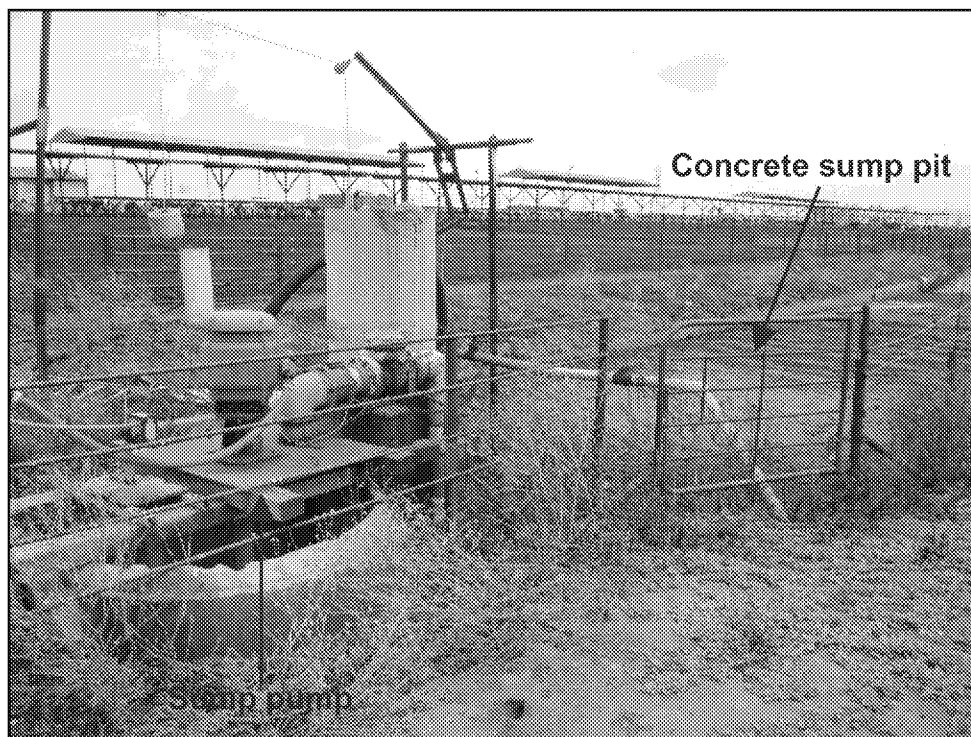
Photograph 2. View facing northwest of the concrete sump pit located in the central-west portion of the Facility.

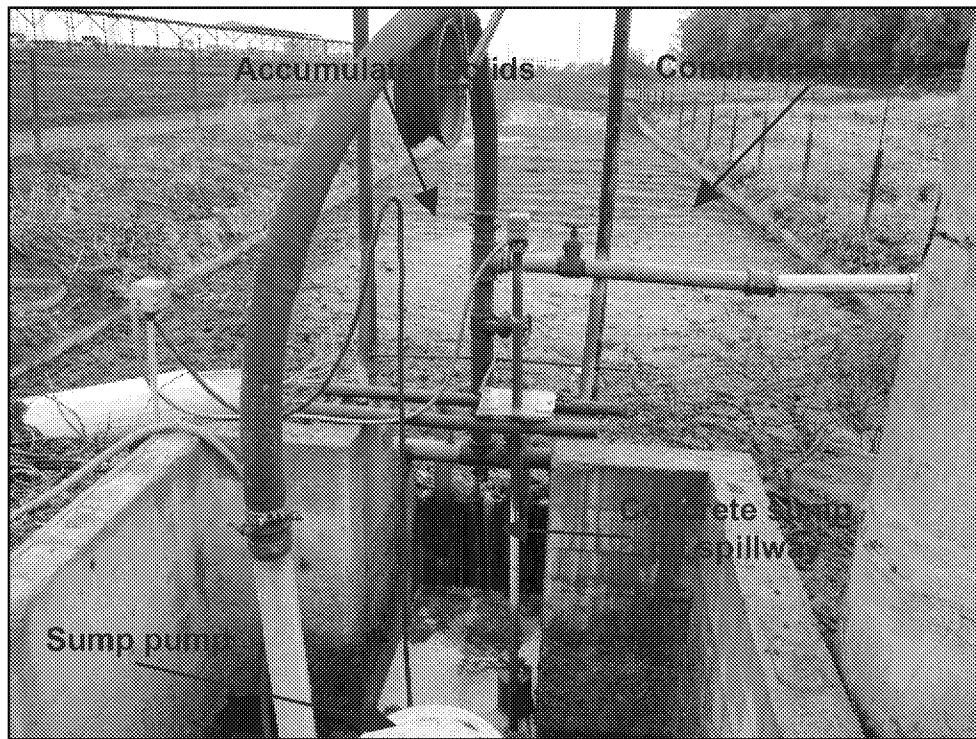
Photograph 3. View facing north of the concrete sump pit located in the central-west portion of the Facility, shown in Photograph 2.

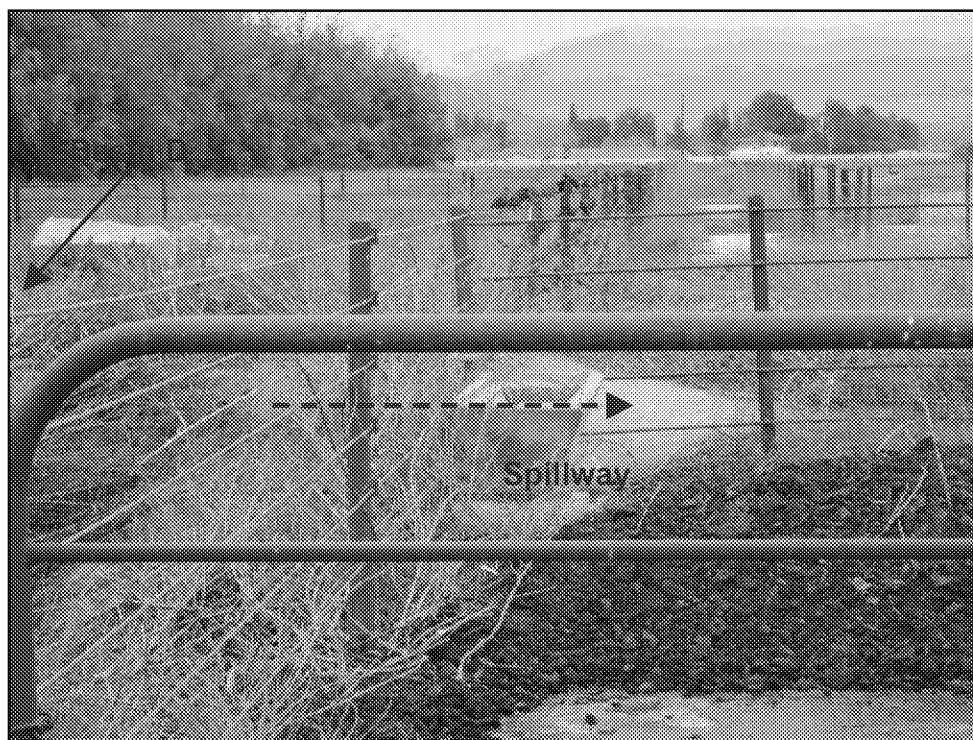
Photograph 5. View facing south of the concrete spillway located in the southwest corner of basin D.

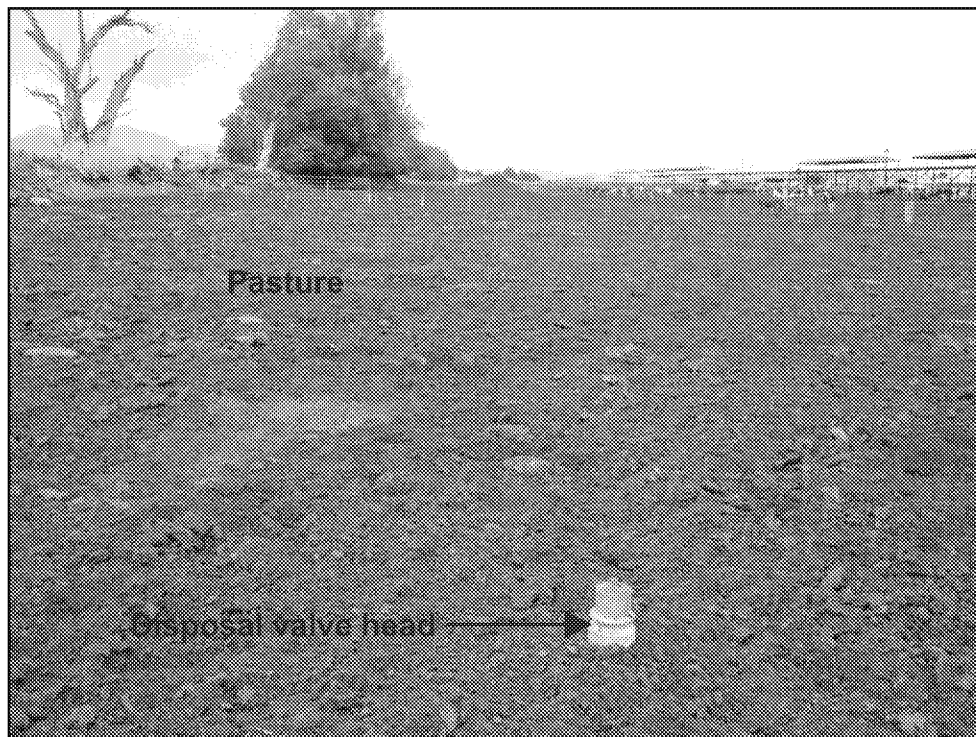
Photograph 14. View facing south of a process wastewater disposal valve head located in the pasture in the northeast portion of the Facility.

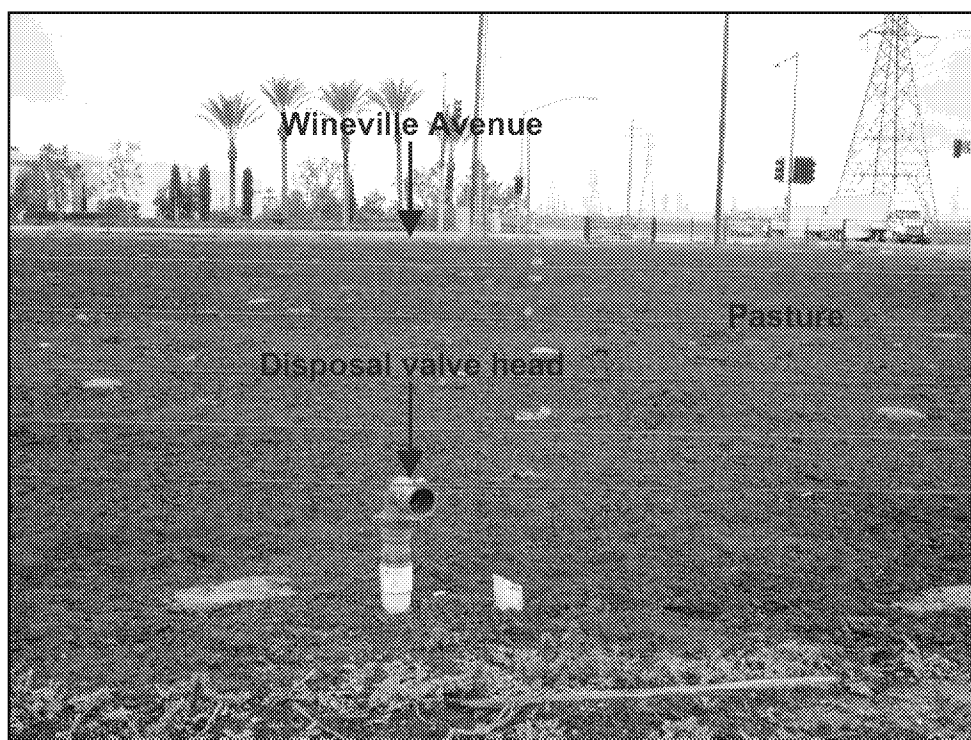
Photograph 15. View facing west of a process wastewater disposal valve head located in the pasture in the northwest portion of the Facility, adjacent to Wineville Avenue.
